## **Development of a Sensor System for Detection of Missing Seeds in a Tractor-operated Groundnut Planter**

To minimize the missing seeds in groundnut planting, an Infra Red (IR) technology based sensor system was developed for a tractor drawn 9- row groundnut planter. This system could detect the number of groundnut seeds falling through a seed tube and provides visual and audible indications of missing drop(s). Laboratory evaluation of the planter with sensor system indicated that the variations of actual number of seeds dropped and display reading varied from 4.97% to 6.72% when operating speed varied from 2.5 km.h<sup>-1</sup> to 3.5 km.h<sup>-1</sup>. The seed rates were 118.53 kg.ha<sup>-1</sup> at 2.5 km.h<sup>-1</sup>, 100.10 kg.ha<sup>-1</sup> at 3.0 km.h<sup>-1</sup> and 93.20 kg.ha<sup>-1</sup> at 3.5 km.h<sup>-1</sup> operating speed. Under field condition, the planter without sensor system had lowest (22.60%) missing seeds at speed of 2.5 km.h<sup>-1</sup>, and highest (32.85%) missing seeds at higher speed of 3.5 km.h<sup>-1</sup>; while the planter with sensor system had 5.92% - 10.84% missing seeds with forward speed varying from 2.5 km.h<sup>-1</sup> to 3.5 km.h<

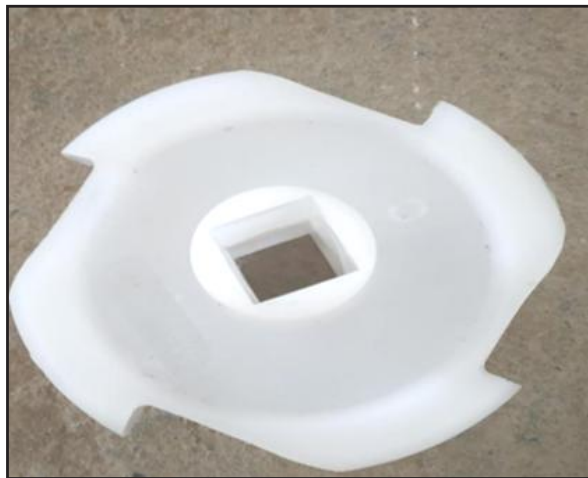
**Fig. 3: Cell type roller**

The planter used a PVC cell-feed roller type seed metering device. It had 4 cells for groundnut seed metering as shown in Fig. 3. The metering device was powered by the ground wheel (300 mm in diameter) through chain and sprocket mechanism. The ground wheel had 12 pegs made of MS flat (40×5 mm). The height of the pegs was 135 mm with triangular tip.

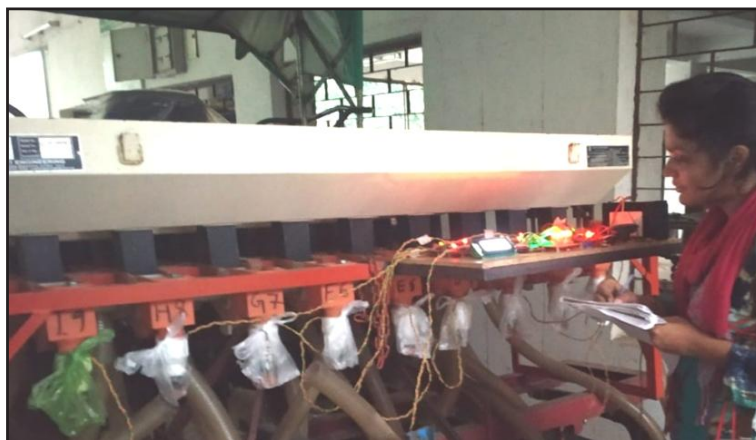
**Fig. 4: Laboratory Evaluation**

A rectangular frame of mild steel (MS) angle (30×30×3 mm) was constructed with frame length of 610 mm and width of 310 mm welded on the seed box frame that connected the 9 seed boxes. The board containing the sensor system, including the battery, was rigidly fixed on the fabricated frame (Fig. 2). The wires from the sensor unit were connected to the IR sensor of each tube, and the tubes were tightly inserted on the tubular seed outlet sleeves of the seed box. Groundnut seeds were filled up to 3/4<sup>th</sup> capacity of the hopper. The 9 rows of the planter were serially named from A to I.

In this experiment, 3 levels of operating speed (2.5, 3, 3.5 km.h<sup>-1</sup>) were considered. The planter was kept in stationary position with the ground wheel lifted above the ground. From each speed, the time required for one revolution of the ground wheel having diameter 30 cm for each speed were calculated, and the ground wheel was manually revolved once within that time period. Ten revolutions of the ground wheel were thus made at 20 s for operating speed of 2.5 km.h<sup>-1</sup>, 16 s for 3 km.h<sup>-1</sup>, and 14 s for 3.5 km.h<sup>-1</sup>. The gear ratio between the driving wheel (ground wheel) and the driven wheel (cup roller shaft) of cell type metering mechanism was 1:1.5; thus, 10 revolutions of the ground wheel would rotate the cell rollers 15 times in one minute. With power supply from a 12V battery to the sensor system, seed fall through the seed tubes fitted with sensors were displayed on the LCD interface with its corresponding row name. Polythene bags were tied at the end of seed tube (Fig. 4) for collecting the actual number of seeds dropped through each row. Thus, the variations between actual number of seeds dropped and that displayed reading was calculated.

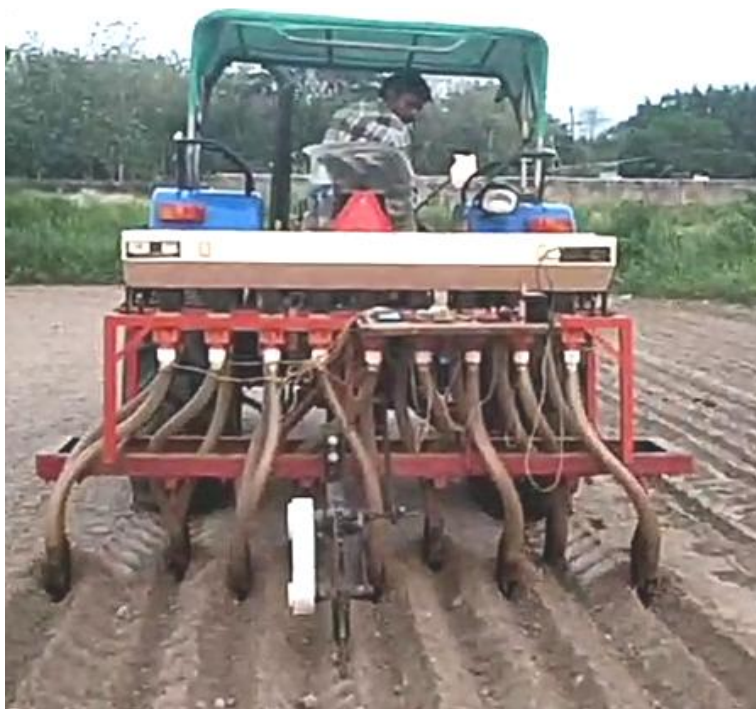
Fig. 8: Field evaluation of planter with sensor system

The planter was evaluated at the Central Farm, OUAT, Bhubaneswar in a plot size was 200 m<sup>2</sup> (Fig. 8). The soil was sandy loam, and the moisture content was 12.23 (% wb) at the time of the experiment. The field was pulverised with tractor-operated rotavator (twice).

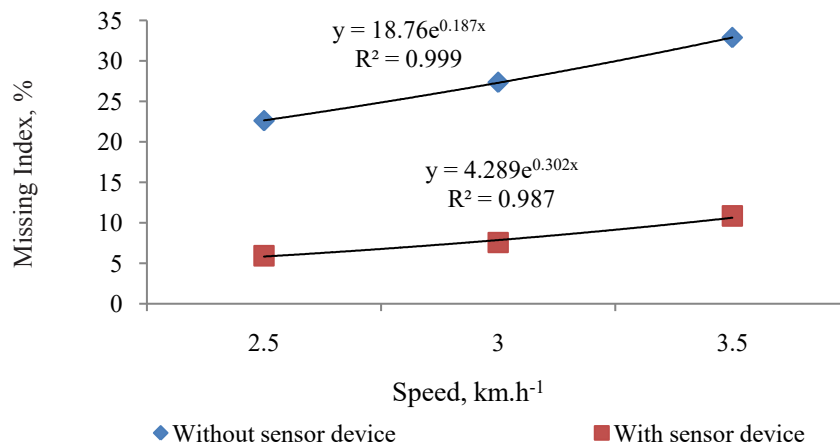
**Fig. 9: Effect of speed on missing index in field condition**

The planter was operated without and with sensor system and the missing index under both conditions were compared. When the planter (without sensor system) was operated at increasing operating speeds, the missing index increased from 22.60% to 32.85%. This might be due to higher planter vibration occurring with increase in operating speed causing the seeds to drop back from the cells in the seed box before falling in seed tubes. At lower speed of operation, negligible dropping of seeds from metering cells back to the seed box took place. Lowest (22.60%) missing of seeds

occurred at lowest operational speed of 2.5 km.h<sup>-1</sup>; while highest missing seeds (32.85%) were observed at highest forward speed of 3.5 km.h<sup>-1</sup>. When the sensor system was attached with the planter; it was observed that the missing seeds varied from 5.92% to 10.84% only. Similar trends of increase in missing seeds with increase in speed were also observed (Fig. 9).

By incorporation of sensor system with the planter the missing seeds were reduced from 22.60-32.85% to 5.92-10.84%. Hence the percentage of missing can be reduced to an extent of 16 to 22% by using sensor

system in the planter. The lower missing seeds with sensor device were due to immediate rectification of the problems indicated by respective row LED glowing, buzzer sound and displaying the row number pertaining to missing.
